## **CSX Kanawha Trestle Inspection Report Charleston, West Virginia**

**Chris Knox, City Engineer**

**Michael Baker Jr., Inc.**

**August, 2011**

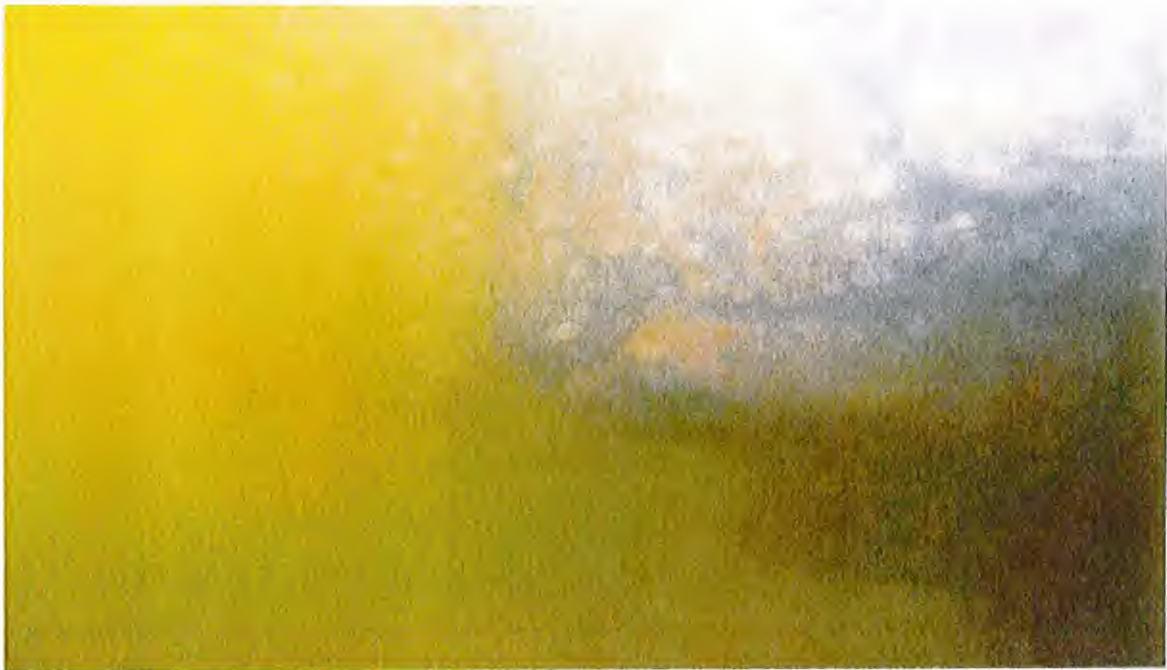
- 2.8.10 An associated significant defect was found situated at the stream bed at this same downstream nose at the corner on the channel side. The concrete at this corner had eroded so that a large void was situated 3 feet above the bed level. It was 2 feet high and 3 feet deep. It extended about 3 feet into the downstream nose.

**Figure 5. An area of eroded concrete on the corner of the downstream nose shore side of Pier 3**

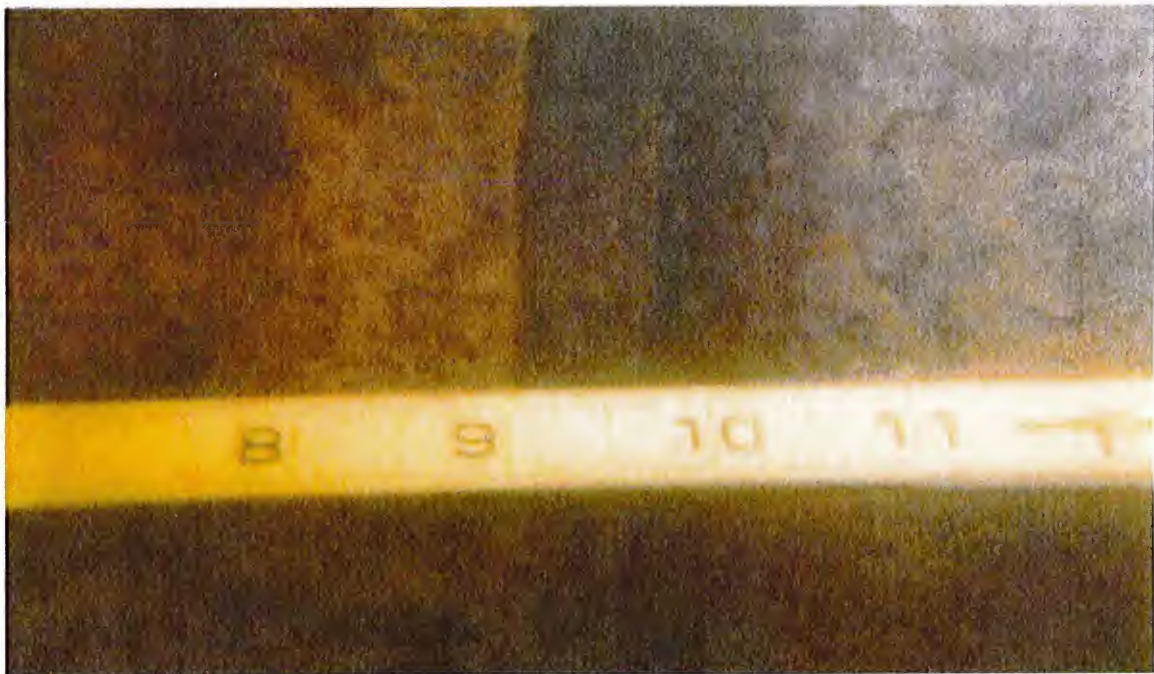
- 2.8.15 A 1.5-inch wide vertical gap at the midpoint shore side of the pier. It was very regular and seemed formed, that is it did not seem to have been the result of concrete deterioration. (See Figure 6)

**Figure 6. A 1.5 inch vertical gap located underwater approximately at the midpoint on the shore side of Pier 3**

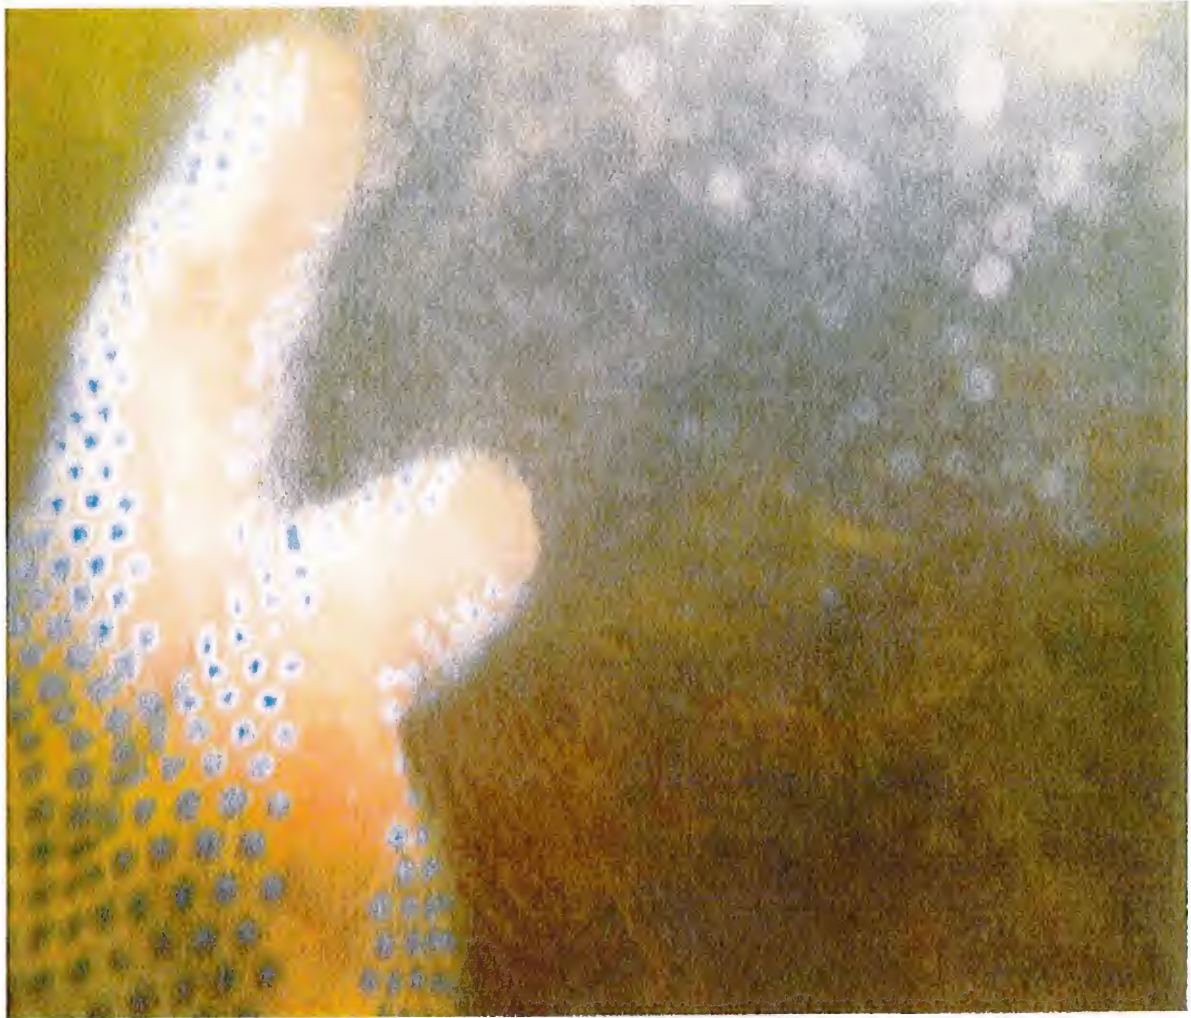
- 2.8.13 A 9-inch x 9-inch timber, apparently from the original construction, rested atop the lowest bench of the footer. It lay all along the channel side from about the point of the break for the point of the pier's to the point of the above-mentioned missing corner.

**Figure 7.** A wooden timber found underwater extruding out approximately 6" from the shore side of Pier 3.
